SCIENTIFIC REPORTS

CT Scanning and MATLAB Calculations for Preservation of Coptic Mural Paintings in Historic Egyptian Monasteries

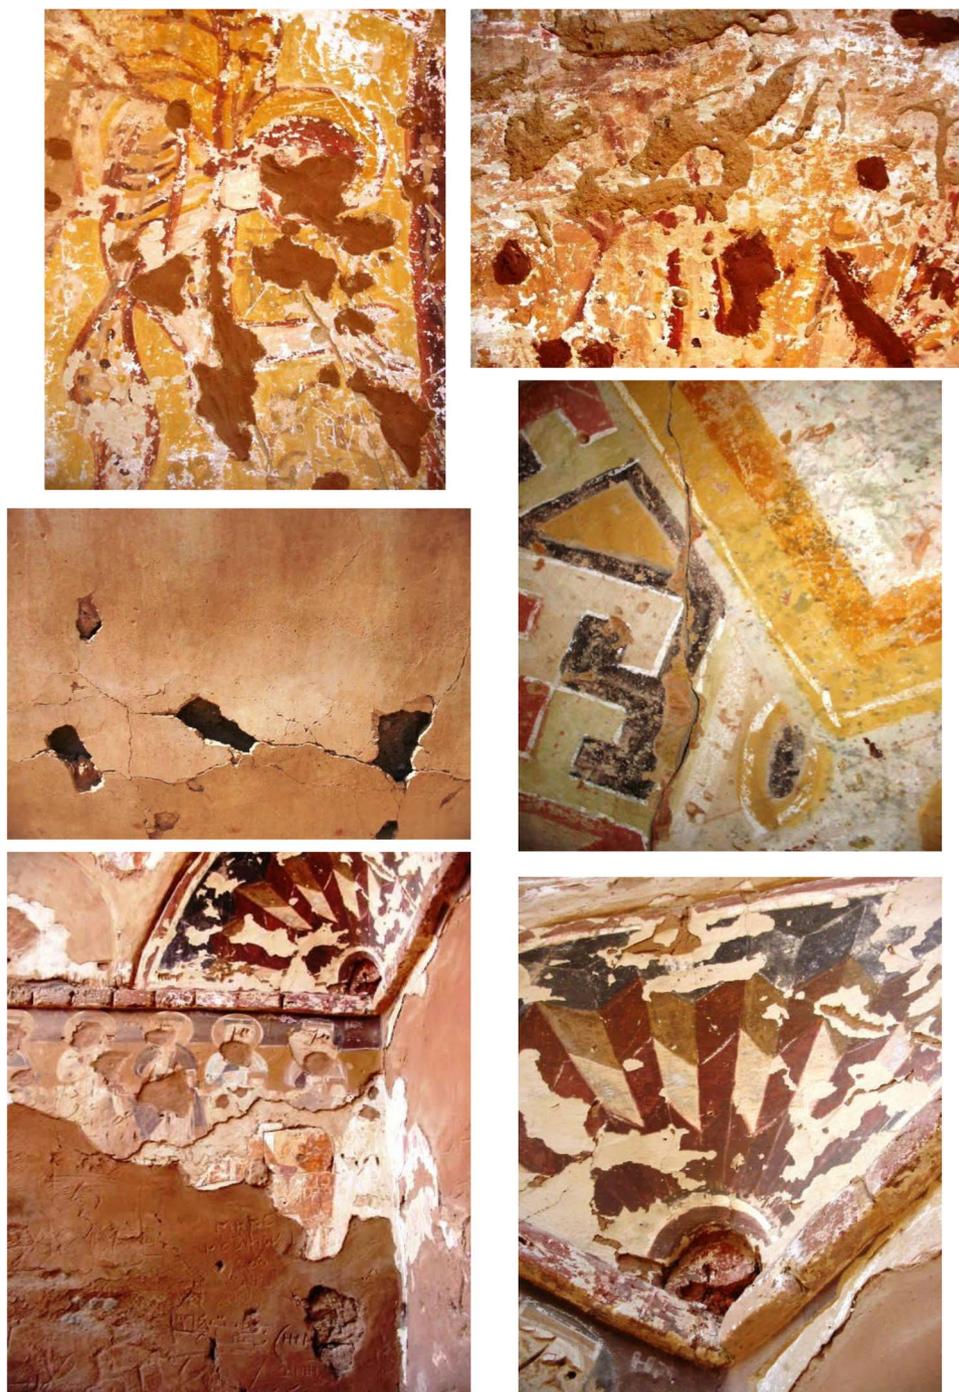
Figure 1. Deterioration of the mural painting at the St. Simeon monastery in Aswan. (a,b) Faulty restoration (c,d) crack formation in the real wall painting and holes, (e) plaster layers back to different periods (f) plaster detachment.

Considerable conservation work remains to be performed at these monasteries, for there are many more Coptic and Arabic texts preserved under a thin layer of plaster. These texts and the murals of the church are very important to the study of the history of Christianity and monasticism in Upper Egypt, and the paintings of the church provide invaluable documentation for the study of Coptic art. Unfortunately, the state of preservation for most of the murals bearing these texts is now very poor, (Fig. 1).

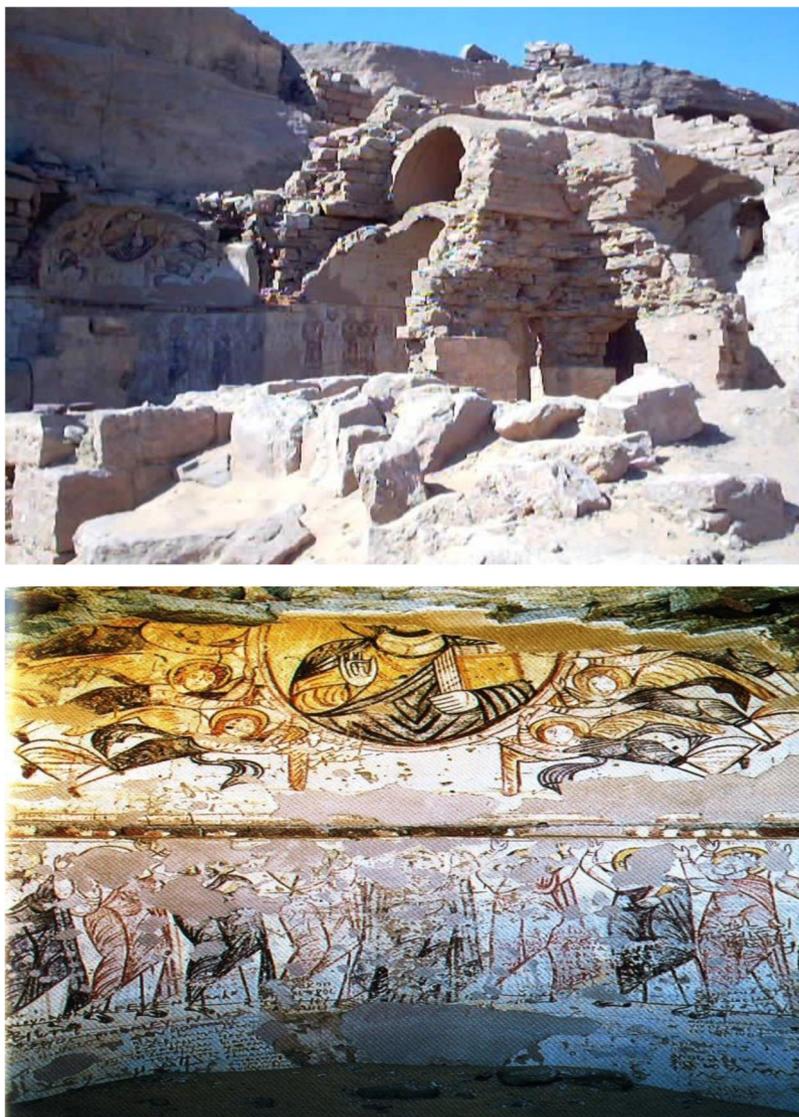
Figure 2. (a) The monastery of Qubbat Al-Hawa. (b) Lower part of an apse depicting the Virgin Mary flanked by the Apostles. The image shows exfoliation of the mural painting layer.

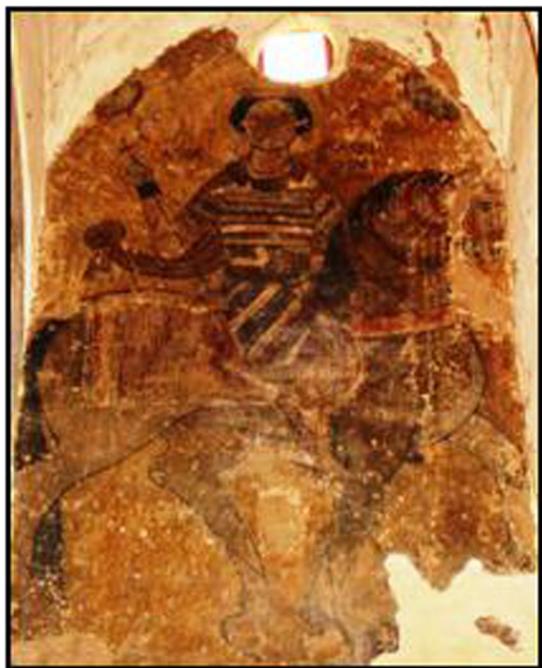
Figure 4. Detachments of parts of plaster.

Saint Matthew the Potter (Deir al-Fakhuri) in Esna - Luxor. The Saint Matthew the Potter Monastery is located at the far edge of the desert of Esna, about 6 miles (9 km) north of the city of Esna (in the Qena governorate), near to ancient Asphynis (present-day Asfun al-Mata'nah). The monastery is dated to the fifth and sixth centuries A.D. and was occupied by monks as recently as 1975. (Fig. 4)^{6–8,12}.

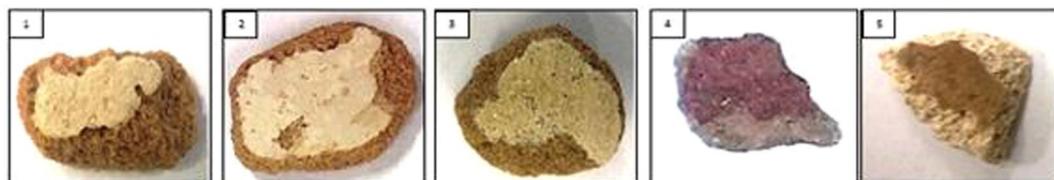
Figure 5. Images of the five samples collected from different sites (1) Monastery of Qubbat al-Hawa. (2) Monastery of Anba Hedra. (3) Monastery of St Matthew the Potter (Al- Fakhuri) near Esna.

The porosity of the samples was determined using MATLAB. The photographic images of the collected samples are shown in Fig. 5, and details of the samples are listed in Table 1. All three monasteries under investigation are in a poor state of preservation; however, the mural paintings in the worst condition are those from the Monastery of Saint Simeon in Aswan. These frescoes have been partially lost due to granular disintegration resulting from chemical-mineralogical-physical changes. Pigments from the paintings had become detached due to temperature variations, so this sample was also examined using EDX.

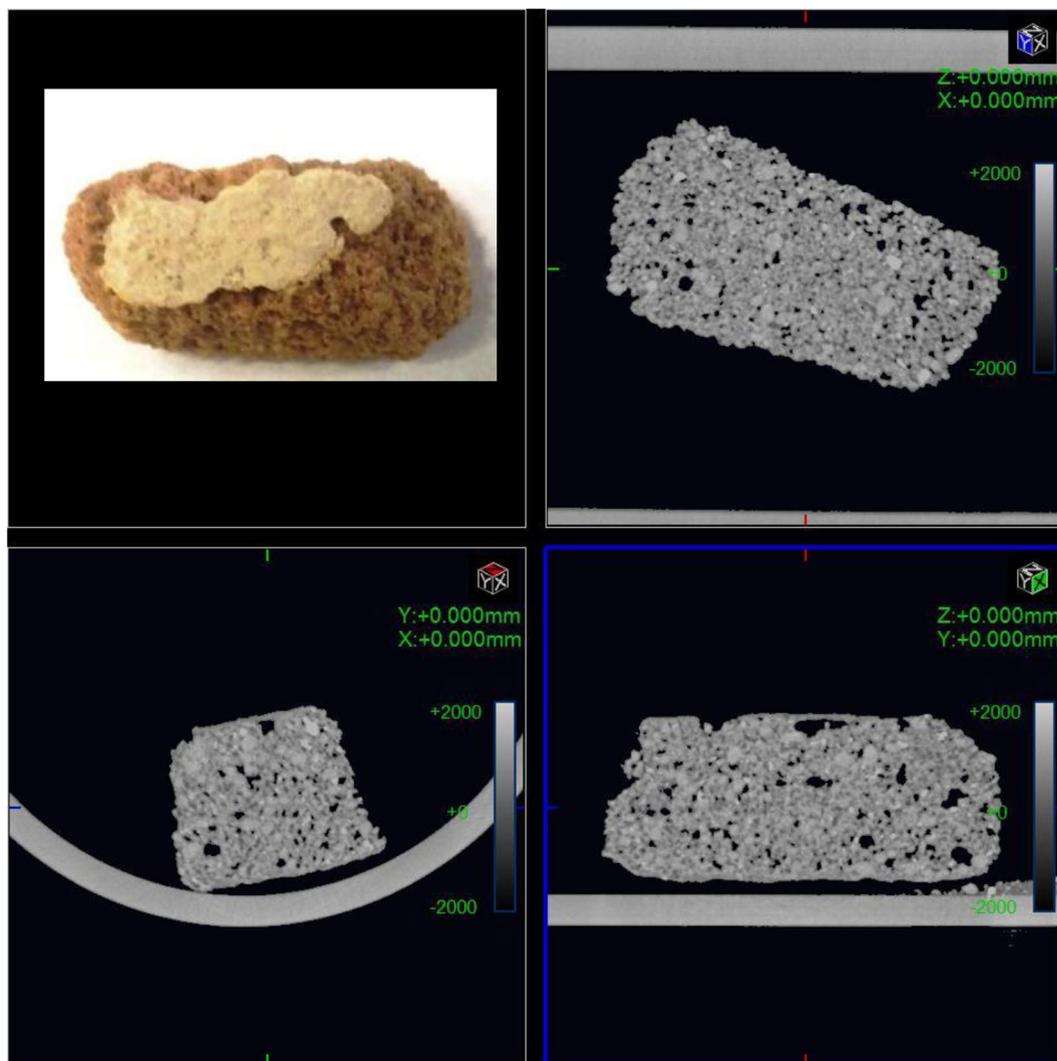
Figure 6. (a) CT image shows the Coptic mural painting at the Qubbat Al-Hawa Monastery in Aswan. (b) CT image of the sample structure shows large porosity due to loss of minerals. (c) CT horizontal section showing overpainting (multi layers). (d) CT horizontal section showing detachment of pigments from the ground.

into the brittle anhydrous phase (anhydrite). The temperature in Aswan shifts dramatically from summer to winter, which causes the plaster to expand and contract repeatedly. Differing levels of expansion between the layers of the mural cause interlayer stress^{17,18} leading to the dislodging of the paint layer, as well as causing cracks, contraction fissuring and peeling of the vertical walls. The continual recurrence of these variations daily and seasonally makes the layers dislodge easily. The CT cross-section images revealed significant information on the hidden parts and overpainting of two layers. The first layer was found to be smooth and the second layer is a little thicker than the first, making it likely that the two layers come from different periods with different qualities and artistic styles as shown in Fig. 6c.

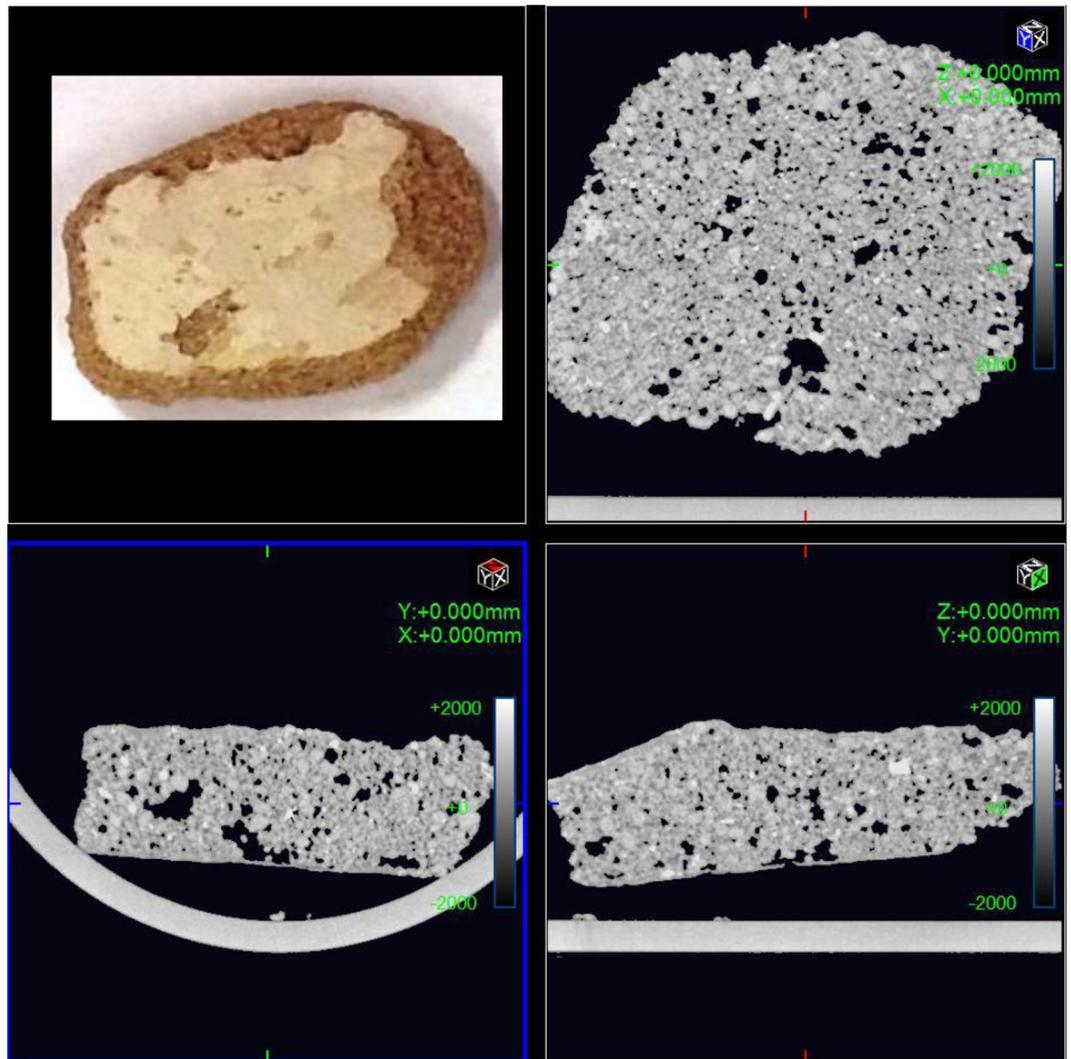
Figure 7. (a) CT image shows the Coptic mural painting from the St Simeon Monastery in Aswan. (b) CT of the horizontal section of the sample showing degradation of the surface, large porosity and loss of cohesion (powdering). (c) CT horizontal section showing flaking and cracked layers. (d) CT image showing two layers of the pigments on the top as well as the bottom degradation of the major composite (quartz) between grains, which leads with time to the loss of quartz grain, cracking and loss of plaster layers, in addition to the coarse lower plaster layer: a composite of quartz, clay minerals and calcite. Loss of quartz grains and clay minerals causes large holes, weak points and loss of the sample in the long term.

Monastery of St. Simeon (Anba Hedra) in Aswan. The characterization of mural samples was performed using CT scanning, as shown in Fig. 7. The samples have been characterized as having a type of surface defect on the plaster as indicated by the calculations completed in MATLAB.

The CT image shows a single slice illustrating the stratigraphy of a model fresco mural painting: two layers were combined in the first layer as a technique to produce good quality. These layers are the richest in quartz (as the major component) and clay minerals (Kaolinite and Orthoclase). The secondary layer is thinner than the first. In addition, some dark areas can be observed in the sample caused by the loss of quartz grains and clay minerals. The CT images show the detachment of the paint layer from the ground layer due to temperature and relative humidity variations, as well as the mechanical stresses and the different physicochemical properties of the samples because of different mineral content, as shown in Fig. 7. The combination of quartz, calcite (CaCO_3) and clay minerals caused the change from gypsum to anhydrite, which is weaker than gypsum. This led to the eventual loss of quartz grains, cracks, loss of plaster layers and large porosity, finally this may lead to the flaking of the outer surface layer and loss of the original painting, as shown in Figs 7 and 8.

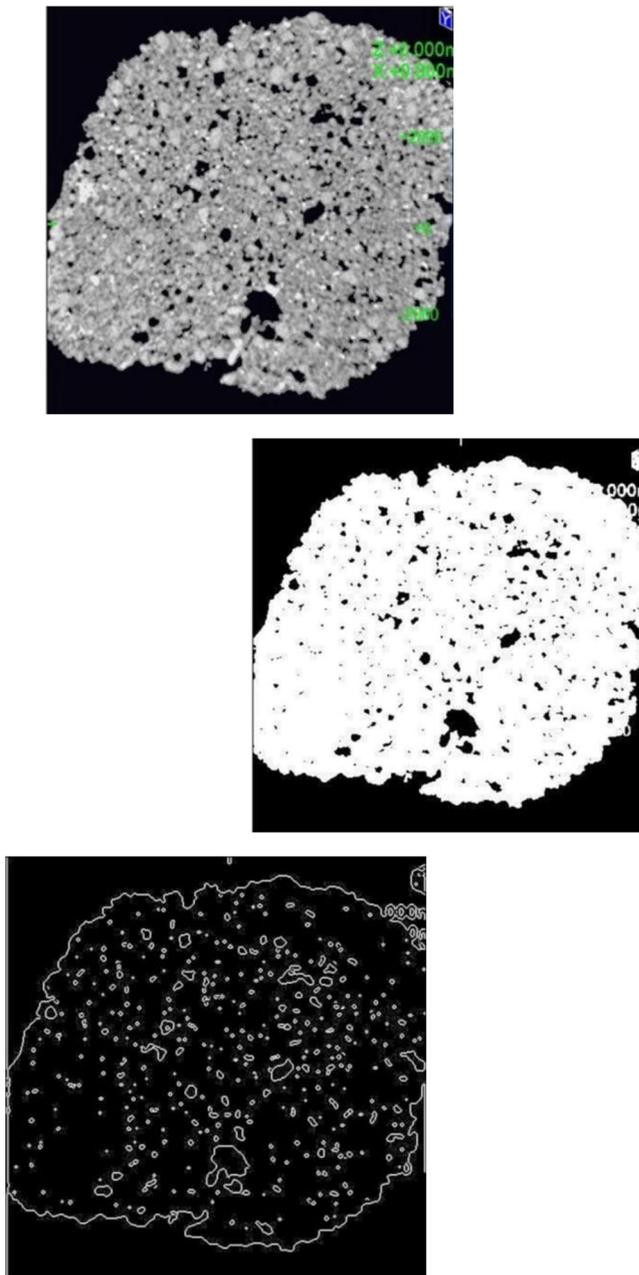
Figure 8. (a) Part one of the sample investigation by CT of the Coptic mural painting from the monastery of St Simeon in Aswan. (b) Black areas show porosity and gaps are due to the loss of binding mortar (c) CT image showing the surface. The black areas show porosity indicating the degradation of most of the surface and the major components.

Figure 8 shows the Porosity and calculations in MATLAB, which is also detailed in Table 2.

Part one of the samples. The sample characterization was completed using CT scanning and the results are shown in detail in Fig. 8. The sample has been investigated to evaluate surface porosity and pore media characterization using MATLAB. The results indicate that the porosity is 0.050 of the total surface, this value signifies that 5% of the surface is porous, indicating a loss of around 5% of the composite minerals in the surface area. Figure 9 presents a plot of total surface porosity.

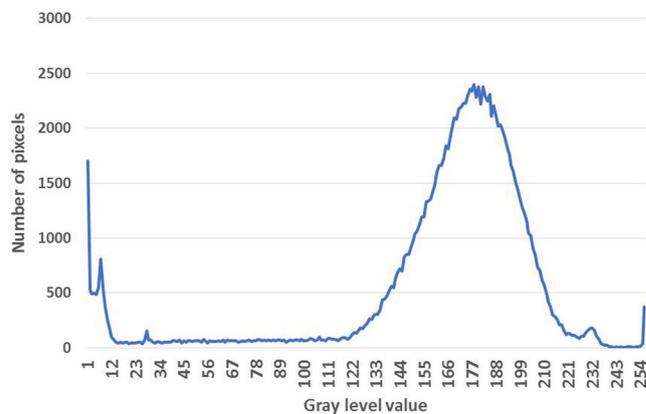
Figure 9. Plot of total surface porosity (part one).

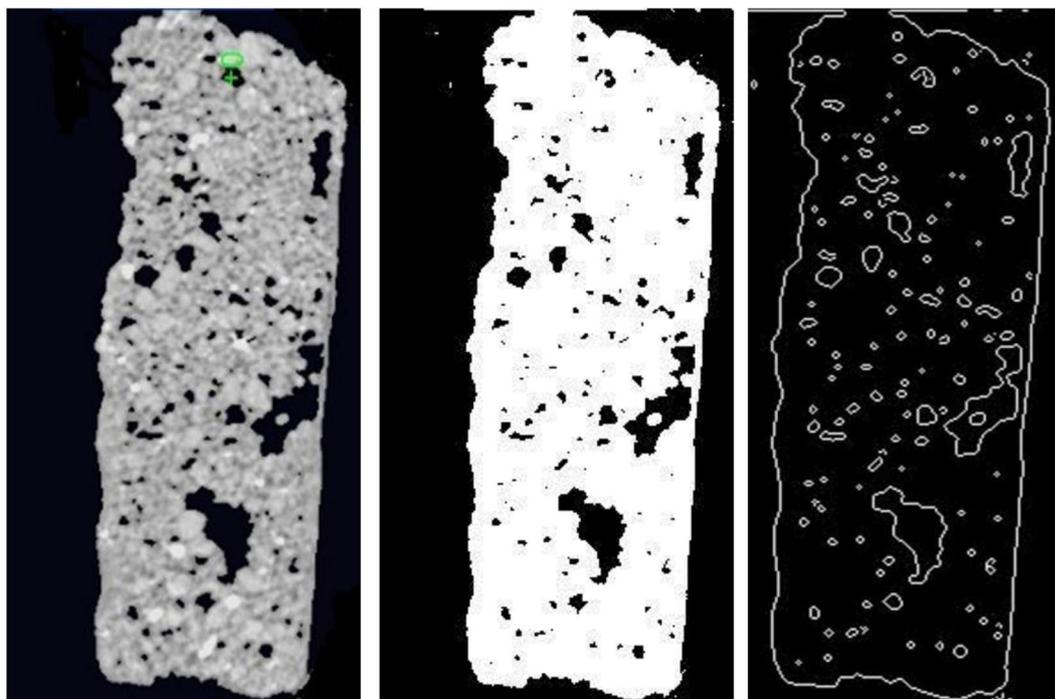
Figure 10. (a) Part two of the sample investigation by CT of the Coptic mural painting from the monastery of St Simeon in Aswan. (b) Black areas show porosity and contain gaps. CT image showing the surface as white areas indicating the loss of most surface area to porosity and deterioration of the major composites.

Part two of the sample. The results of the CT scanning are shown in Fig. 10. The MATLAB calculations show that the sample has a porosity of 0.045 of the total surface. This value indicates that the surface porosity is high and there is a loss of around 5% of the composite minerals. Figure 11 shows a plot of the porosity of the total surface. CT scan images and MATLAB analysis allow the evaluation of porosity within the bulk volume of samples.

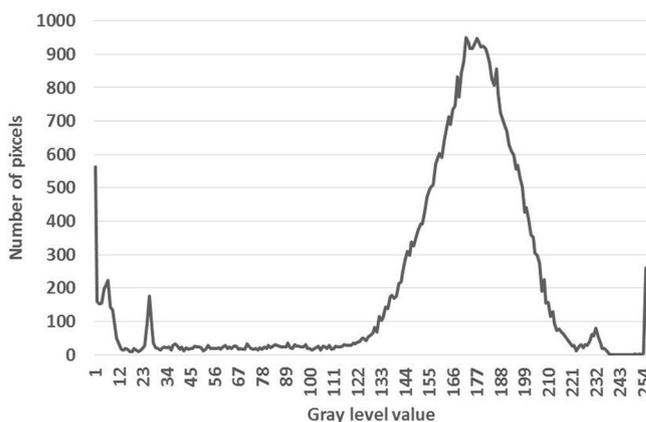
Figure 11. Plot of total surface porosity (part two).

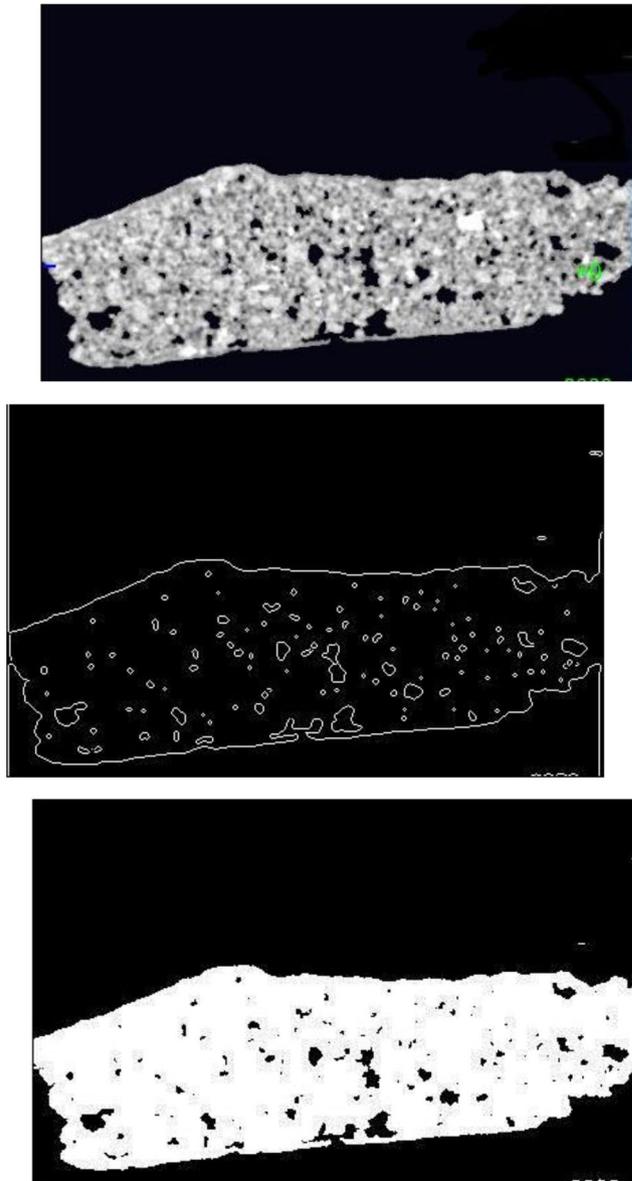
Figure 12. (a) Part three of the sample investigation by CT of the Coptic mural painting from the monastery of St Simeon in Aswan). (b) Black areas show porosity and contain gaps. CT image showing the surface as white areas with porosity areas in black indicating the loss of most of the surface and the major composites.

Part three of the sample. Figure 12 shows the images from CT scanning. The sample has been characterized using MATLAB which indicated that the porosity is 0.078 of the total surface; this value indicates a loss of around 8% of the mineral composite. Figure 13 shows a plot of the porosity the total surface. The results from all three parts are summarized in Table 2.

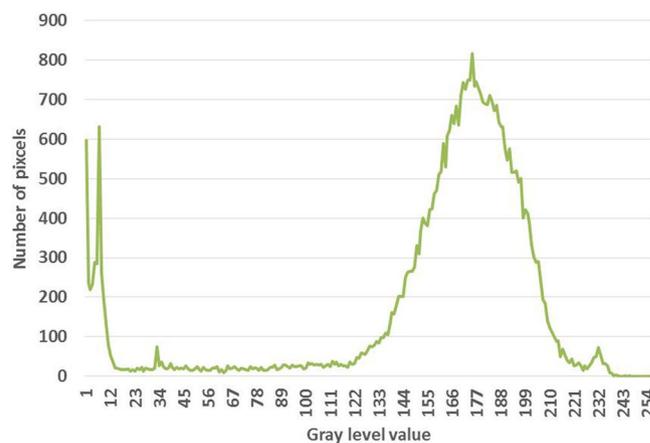
Figure 13. Plot of total surface porosity (part three).

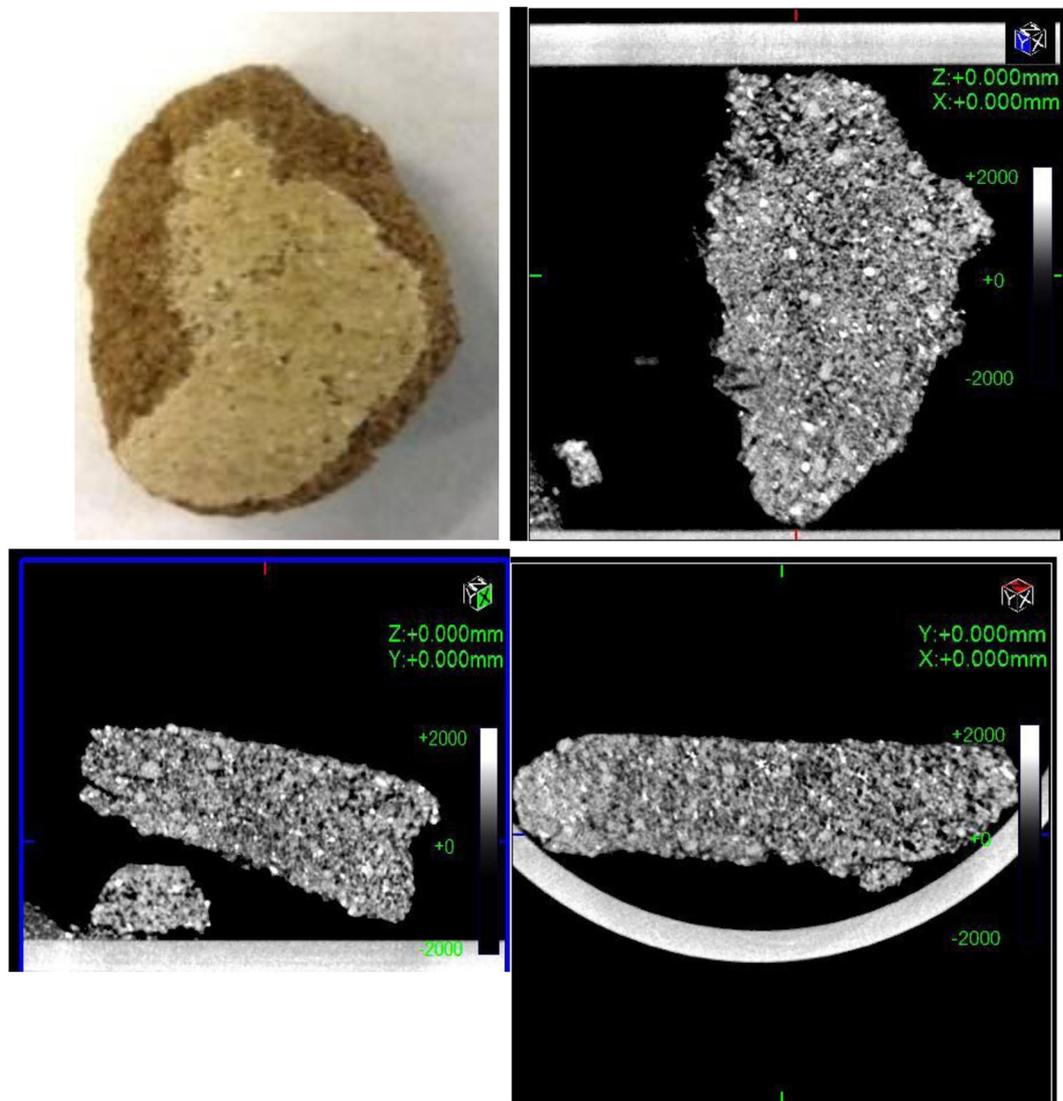
Figure 14. (a) Three orthogonal views of the mural painting from the monastery Matthew the Potter (Esna – Luxor) required for obtaining morphometric measurements. (b) CT horizontal section of the sample showing degradation of the surface, porosity and white areas are calcite and gypsum. (c) CT horizontal section showing the paint layer starting to flake and visible layer cracking. (d) CT showing degradation of the major composite (quartz) between grains leading in time to loss of quartz grain, cracks and loss of plaster layer.

Al Fakhuri Monastery – Esna. The CT image (Fig. 14) of the sample from the Al Fakhuri Monastery shows that the painted layer has been applied directly on top of the coarse lower plaster layer. The plaster in this monastery was applied in one layer, which was the surface layer. The sample has been characterized to yield the grains dimensions in the surface and shape.

The cross-section stratigraphy of the painted layer reveals it to be a single composite layer. The gray areas are clay minerals, the white areas are quartz, calcite and gypsum, but the black areas are loss of composite minerals.

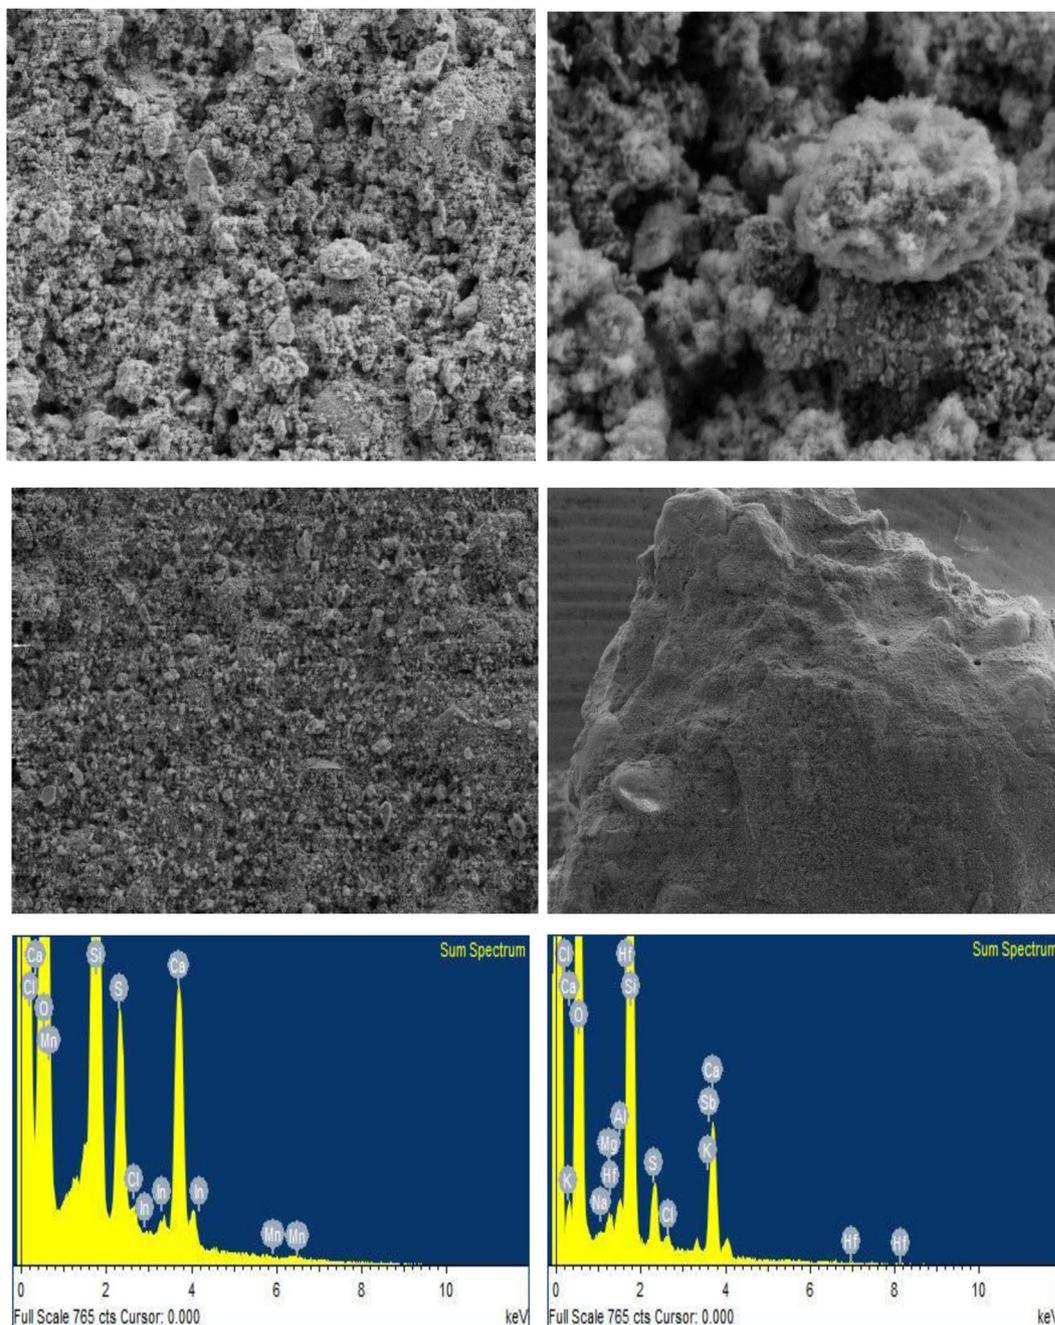
Figure 15. (a–d) SEM showing morphology of the coarse lower plaster layer of the St Simeon monastery, (e,f) EDX spectrum of a small area taken from the coarse lower plaster layer of mural at the monastery of St Simeon in Aswan.

Energy Dispersive X-Ray Analysis (EDX). EDX micro elemental analysis was conducted on the coarse lower plaster layer of the fresco murals from the monastery of St. Simeon in Aswan. The results showed the presence of different elements sodium (Na), manganese (Mn), magnesium (Mg), aluminium (Al), silica (Si), sulphur (S), chloride (Cl), and calcium (Ca), which are presented in Fig. 15e,f and are summarized in Table 3.
